DEPARTMENT OF TRANSPORTATION**DIVISION OF ENGINEERING SERVICES**

Contract #: 04-0120F4Cty: SF/ALA Rte: 80 PM: 13.2/13.9File #: 69.28**WELDING INSPECTION REPORT****Resident Engineer:** Pursell, Gary**Address:** 333 Burma Road**City:** Oakland, CA 94607**Report No:** WIR-001695**Date Inspected:** 18-Feb-2008**Project Name:** SAS Superstructure**OSM Arrival Time:** 700**Prime Contractor:** American Bridge/Fluor Enterprises, a JV**OSM Departure Time:** 1500**Contractor:** Zhenhua Port Machinery Company, Ltd (ZPMC), Changxing Island **Location:** Shanghai, China**CWI Name:** Xu Le Feng, Ye Yong Jun**CWI Present:** Yes No**Inspected CWI report:** Yes No N/A**Rod Oven in Use:** Yes No N/A**Electrode to specification:** Yes No N/A**Weld Procedures Followed:** Yes No N/A**Qualified Welders:** Yes No N/A**Verified Joint Fit-up:** Yes No N/A**Approved Drawings:** Yes No N/A**Approved WPS:** Yes No N/A**Delayed / Cancelled:** Yes No N/A**Bridge No:** 34-0006**Component:** Tower Mock-ups and OBG**Summary of Items Observed:**

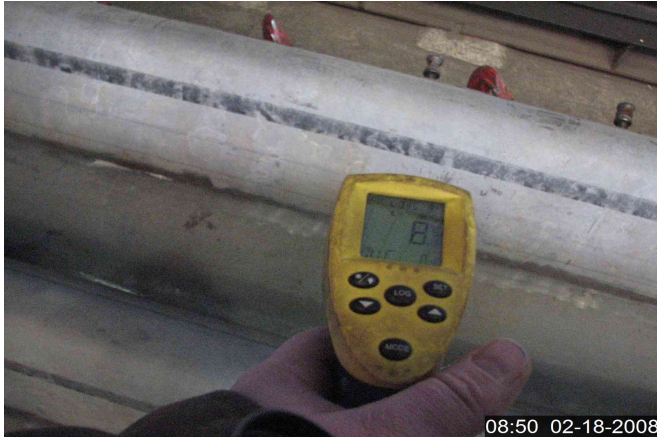
The Quality Assurance Inspector observed ZPMC fitting up and tack welding of closed U ribs to deck plate DP-014-001, utilizing the flux cored arc welding process to produce the tack welds in the horizontal position.
